ANNUAL REPORT
OF THE
ARCHÆOLOGICAL DEPARTMENT,
SOUTHERN CIRCLE, MADRAS,
FOR THE YEAR
1911-1912.

ARCHÆOLOGICAL DEPARTMENT,

SOUTHERN CIRCLE, MADRAS,

1911-1912.

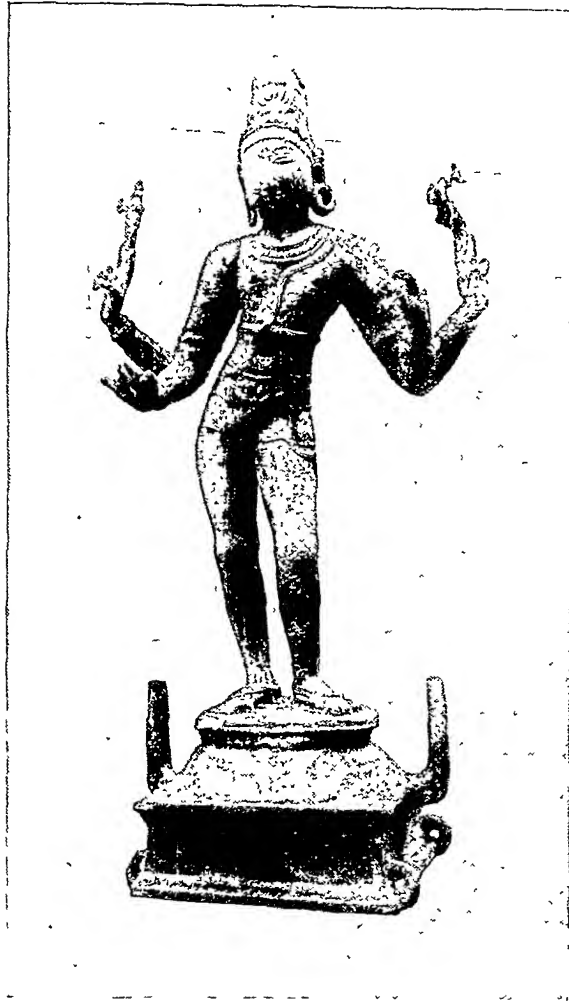
Fig. 1.

17. A bronze idol (plate I, Fig. 1) and some grinding stones were found during some excavations in the temple of Jembukēśvarasvāmi at Vadarāṅgam of the Tañjore district. The digging was in connection with the intended construction of a well within the temple and the work commenced on the 3rd October 1910. On the first day, a copper *gandī* (water vessel) and two brass plates were discovered; but these, on being taken out, crumbled to pieces. On the 4th idem, the idol was discovered at a depth of about 3 feet below ground, and this being ancient its acquisition was recommended. Further excavations have resulted in the unearthing of an old well of brick in mud within which were some stone grinding stones. The well has been found to have a profuse supply of water from an underground spring. Vadarāṅgam.
